APOLLO 14 MISSION
FOOD PREPARATION UNIT LEAKAGE
ANOMALY REPORT NO. 1

APOLLO 14 MISSION

FOOD PREPARATION UNIT LEAKAGE

Anomaly Report No. 1

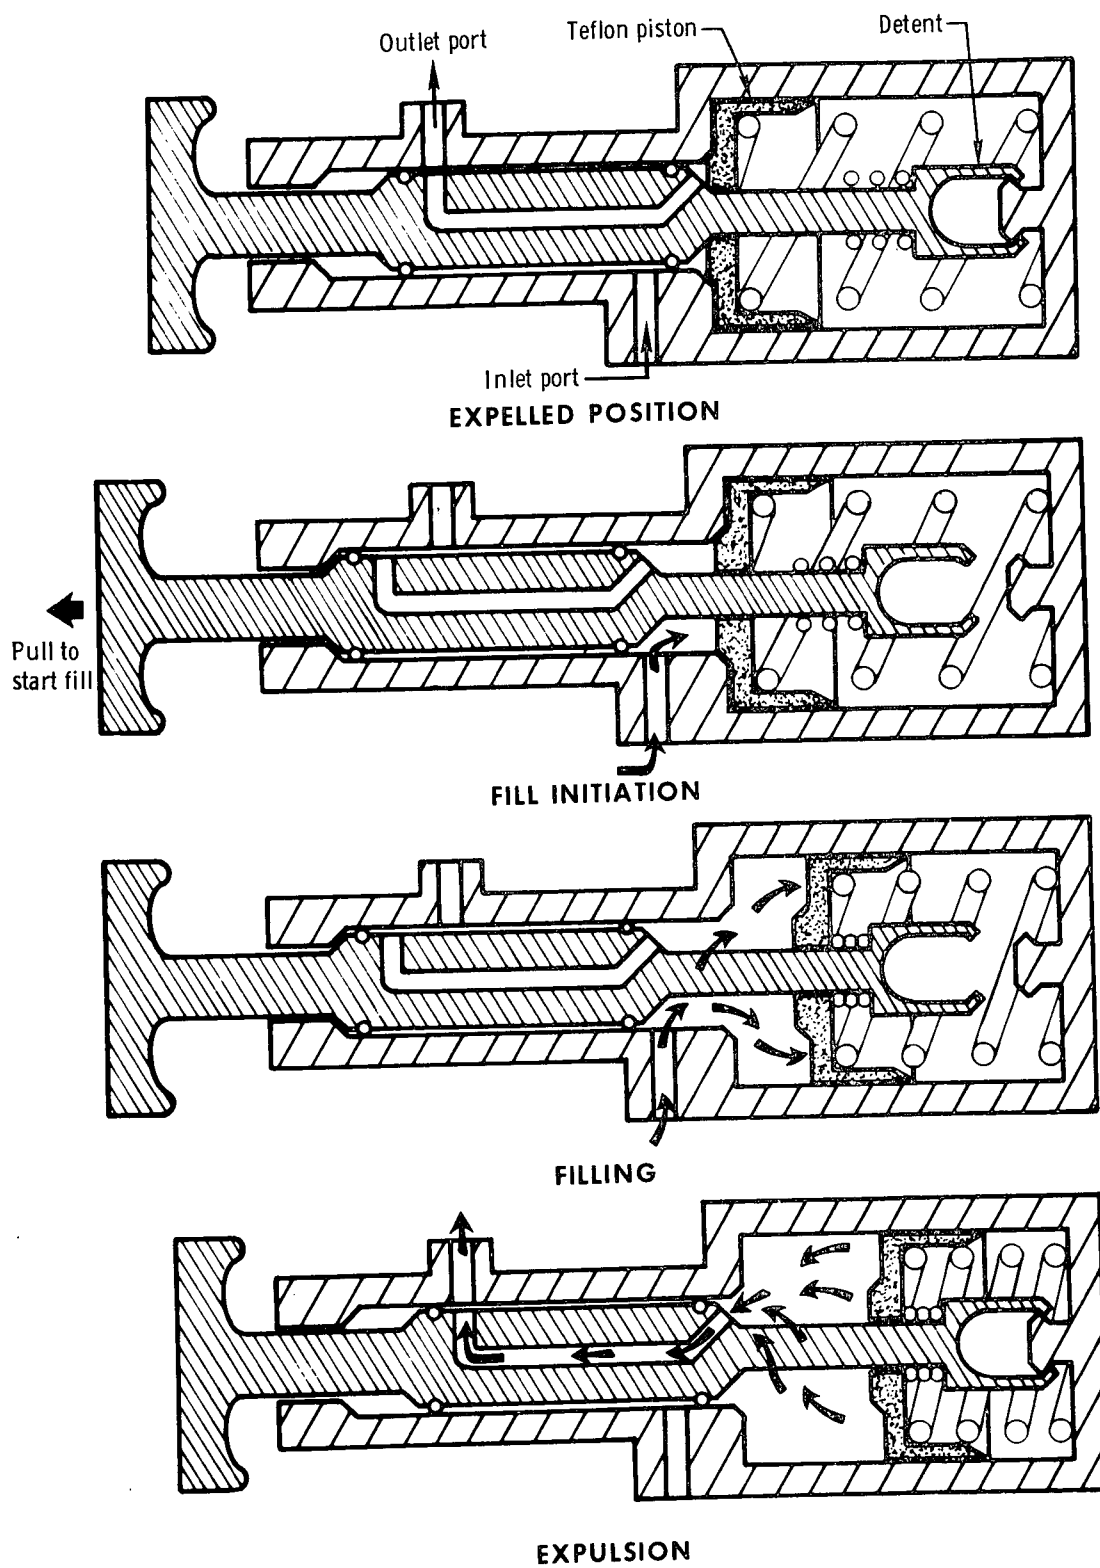
Figure 1. - Metering valve operation.

Hot water is dispensed through a metering valve which consists of a shuttle valve and a spring-loaded Teflon piston that rides in a metering cylinder (fig. 1). Pulling the valve handle moves the shuttle valve to the fill position. Water then enters the metering cylinder through the fill port and water pressure forces the piston back against its return spring until the metering cylinder is filled. When the piston reaches its maximum travel, the shuttle valve closes the fill port and opens the drain port. The return spring then forces the piston forward, expelling the water out the drain port.

Inspection of the disassembled valve showed no damage or contamination. Dimensional checks showed that at 73° F, the Teflon piston (fig. 1) diameter was 1.487 inches or 0.001-inch oversize, and the cylinder diameter was 1.493 inches, the smallest allowable. At 159° F, the maximum expected flight temperature, the piston expanded to 1.495 inches and the cylinder expanded to 1.494 inches. The piston diameter was then 0.001-inch larger than the cylinder.

With the piston return spring removed, 7 pounds force was required to expel all of the water at 154° F, the nominal flight water temperature. Since the piston return spring supplies 5 pounds force with the cylinder empty and 12 pounds force with the cylinder full, the piston would stall during the expulsion part of the valve cycle and the valve would deliver a reduced quantity of water. The piston would subsequently have a tendency to creep and slowly deliver the trapped water, giving the impression of a leak.

Dimensional interference between the cylinder and piston at the hot water temperatures produced the apparent leak by causing erratic and slow stroke time of the valve assembly.

Hot water expulsion tests will be conducted on subsequent spacecraft during checkout to insure dimensional compatibility.
